VOLUME 71 • WINTER 2015 • NUMBER 4

THE CURRENT STATE OF THE WRECK OF THE BRIG *SULTAN*

by David M. VanZandt MMA, RPA, Jim Paskert, Kevin Magee,
Chris Kraska, Ken Marshall, and Linda Pansing

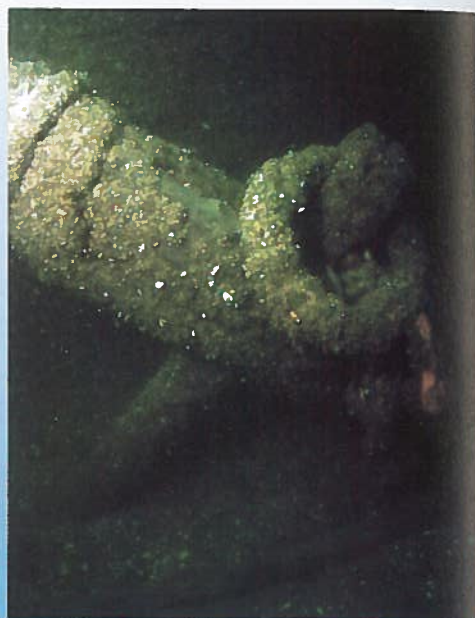
The ship's bow, missing the bowsprit, is pointed east and stands five feet high off the sand/mud bottom. The hull sides are intact and the majority of the decking is present. Two anchors are present and visible lying on the bottom off either side of the bow. A wood-stocked bower anchor is partially buried on the port side still attached to its anchor chain. A metal stream or small bower anchor, with a 90 degree-shaped wooden cathead still attached to it, is mostly buried on the starboard side with a grindstone on top of it.

Wood-stocked bower anchor, port side.
Photo by Chris Kraska, MAST

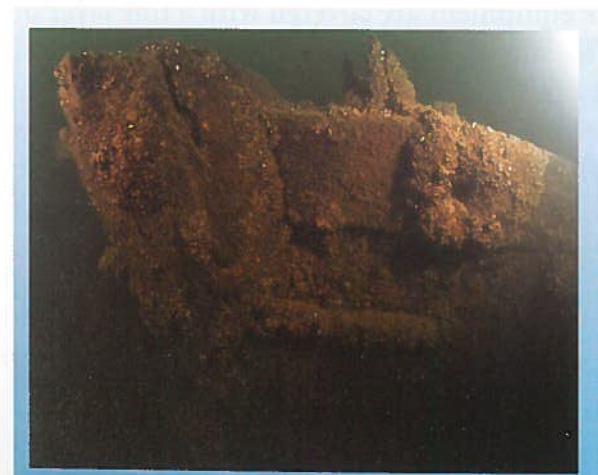
The bow of the ship features a prominent cutwater with a notch for the missing bowsprit. The disarticulated bowsprit rests on the bottom 42 feet to the east of the bow. A windlass is located on the forward deck just aft of the bowsprit notch. Aft of the windlass is a small square access opening in the deck to the chain locker, which is filled with anchor chain. Two separate anchor chains run from the chain locker. The port anchor chain runs from the chain locker through its spurling pipe and loops back into the chain locker. It then comes back out of the chain locker where it wraps around the port whelp of the windlass. From the whelp it

Bow and cutwater.
Photo by Jack Papes

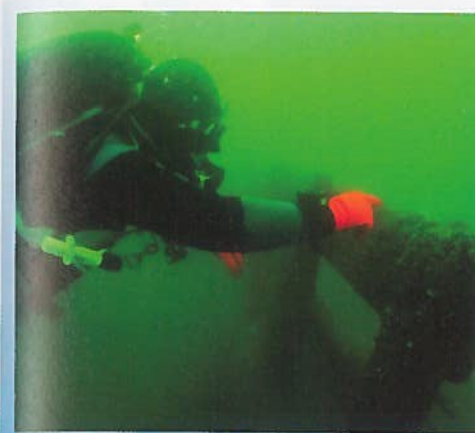
Intact port railing.
Photo by David VanZandt, CLUE

The wreck has an obvious list of about 30 degrees to starboard. The railings on both the starboard and port sides are mostly intact. Round grindstones are piled up on the deck along the inboard starboard railing in stacks of one, two, or three stones high and in several rows. The grindstones start near the foremast and continue all the way to the stern. The larger stones, about 5.5 feet in diameter, are located forward, and the smaller stones, about 3.5 feet in diameter, are located toward the stern.

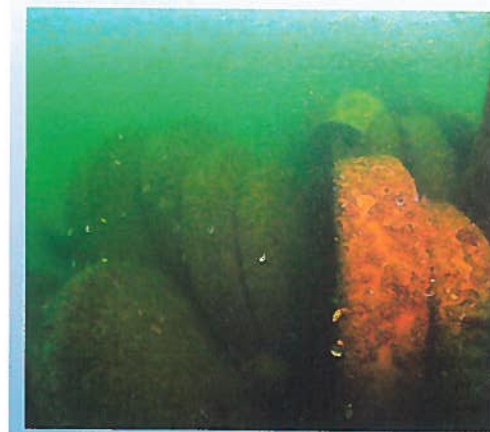
Grindstones along starboard site.
Photo by David VanZandt, CLUE

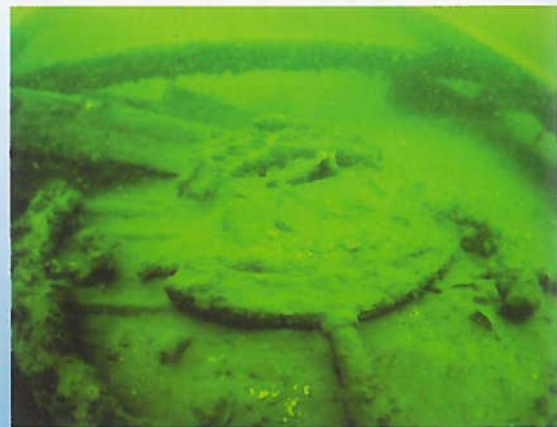
The deck of the *Sultan* is strewn with a variety of disarticulated deck hardware. Some of the hardware has been identified and some has yet to be. One of the most identifiable pieces of deck hardware is the broken ship's wheel located near the stern where the cabin once stood.

Broken ship's wheel.

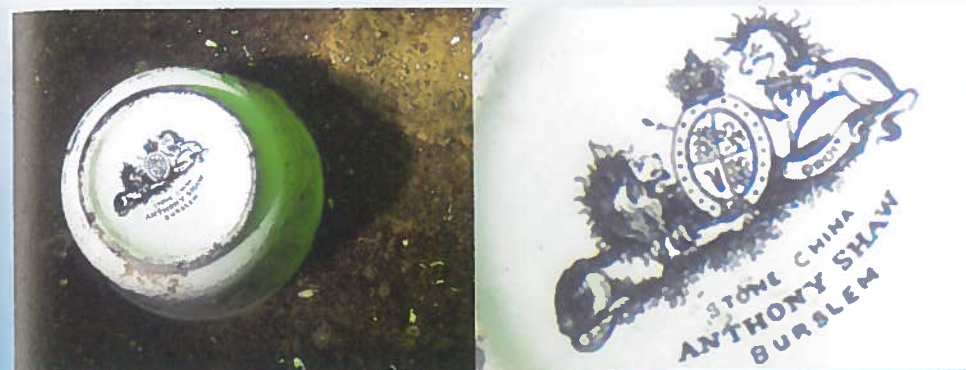
Anthony Shaw Cup.

A quantity of ceramic items including a cup and several plates manufactured by Anthony Shaw of Great Britain — as evidenced by the maker's mark — were found on the wreck. These marks date to the period of ca 1860–1882, consistent with the wrecking event (Thepotteries.org, 2014a). This tableware appears to be one of the designs manufactured by Shaw and distributed exclusively in the United States. It was likely stocked on the brig as part of its standard galley dishware during the *Sultan's* time in New York City from 1859–1861.

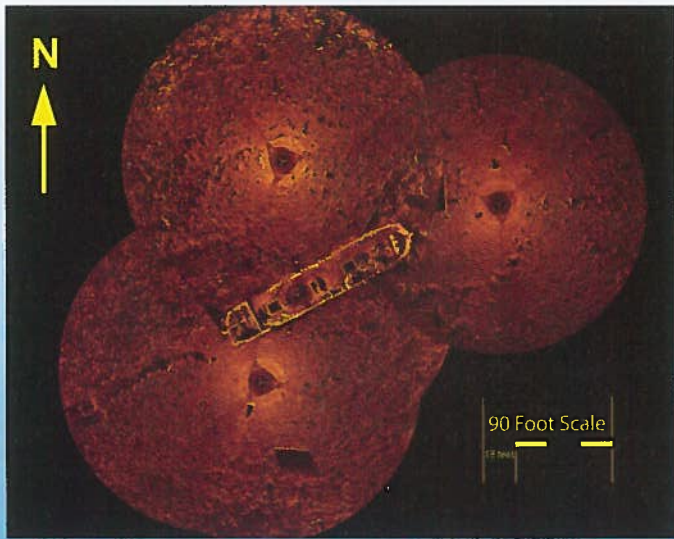
Sultan 360 Sonar 90 ft composite image.
Brian Abbot, Nautilus Marine Group International, LLC
